## Pedestrian Infrastructure and Accessibility

*Findings from CAG's Jane's Walk - Chennai Edition*

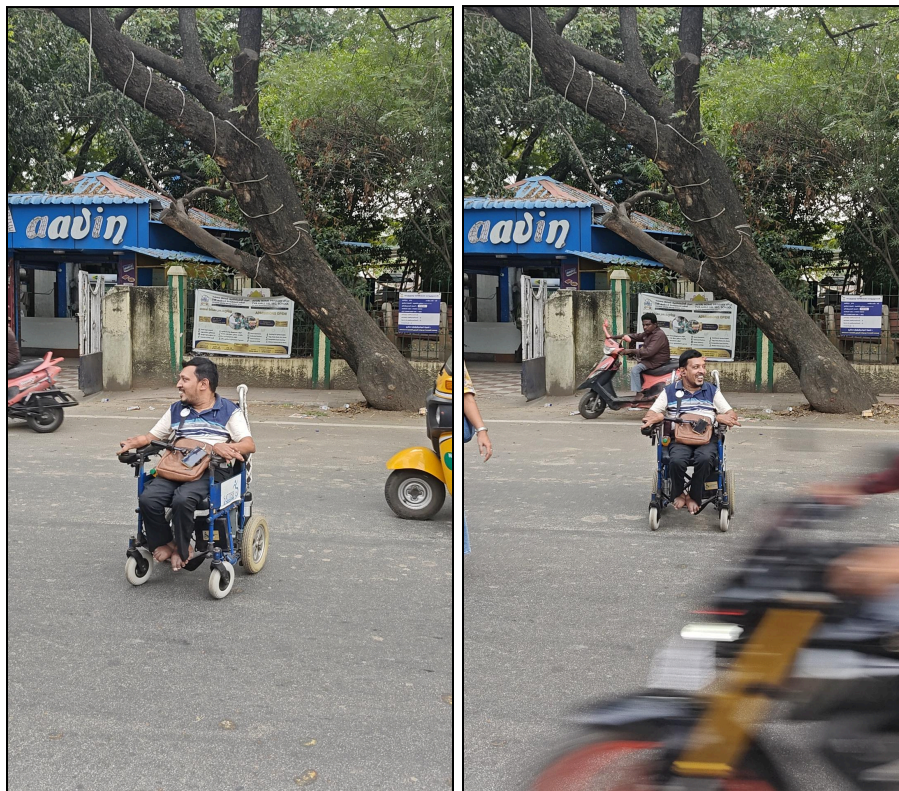
*Sathish Kumar R (Member of Disability Rights Alliance) finding it extremely difficult to cross the road near Dr. Muthu Lakshmi Park. | [CAG](#)*

- **Pedestrian Crossings:** Road crossings are largely absent along the stretch although people continue crossing the road anywhere they find or feel is safe. These are pedestrian behaviours and needs that design has not taken into consideration. Pedestrian crossings need to be established at shorter intervals along the route (eg. near Dr. Muthu Lakshmi Park, Blue Cross Road intersection).

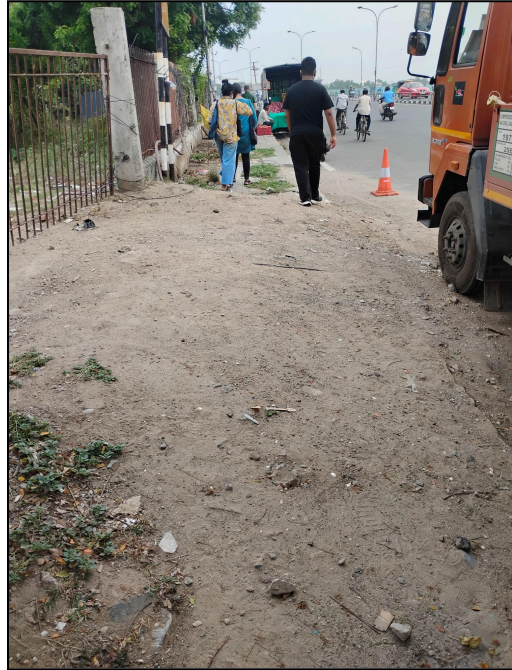
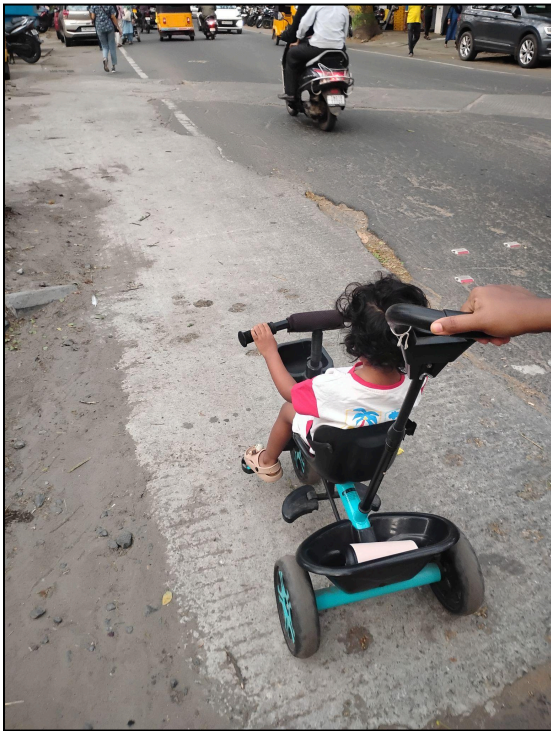
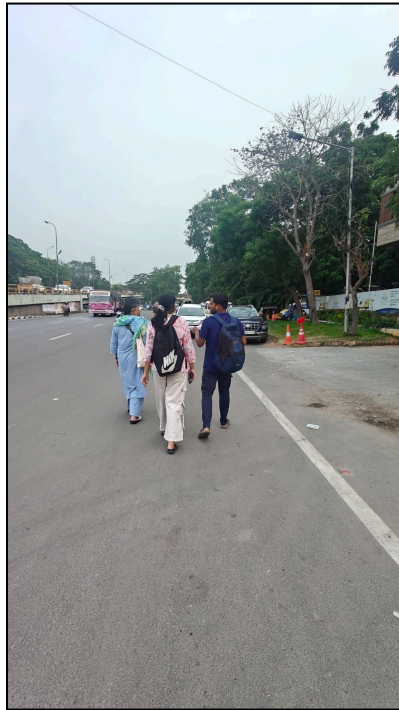
*Completely missing footpaths on the Jane's Walk route | [CAG](#)*

As seen above, footpath facilities were found to be completely absent on many parts of the walk.

- By Design: Footpaths were absent in parts of the walk by design. Footpaths need to be planned and executed on parts of the road where they are absent.

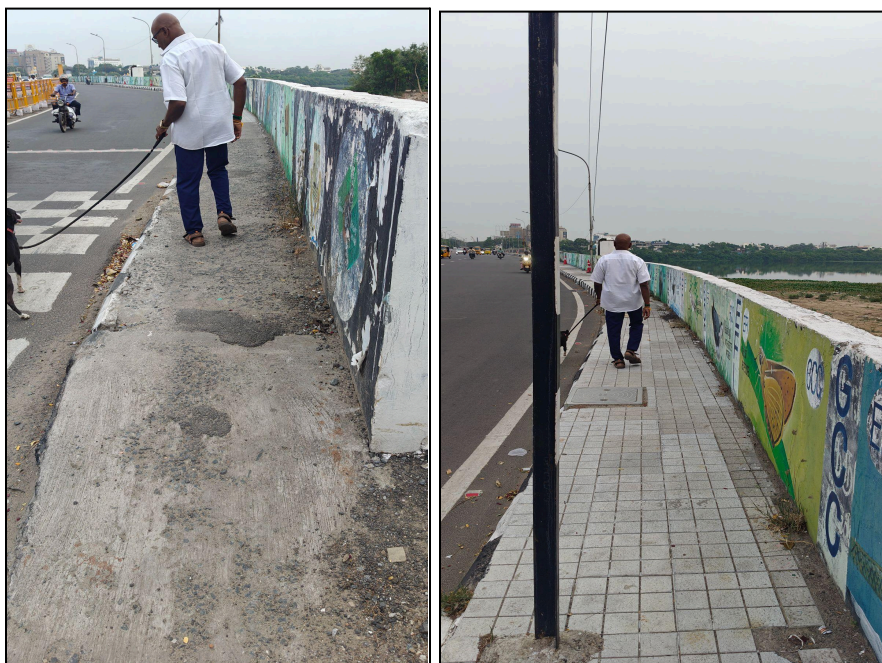
*Pedestrian using the footpath on the Adyar Bridge (Thiru-Vi-K-Bridge) and not finding enough space for his pet on the footpath| [CAG](#)*

As seen above, the road user did not have enough space for himself on the footpath leading up to the Adyar Bridge (Thiru-Vi-Ka Bridge).

- **Accessibility:** Almost all of the pedestrian infrastructure remains inaccessible by people with disabilities and senior citizens.
  - **Footpath width:** IRC Guidelines recommend that footpaths width be at least 1800mm wide, which was not the case in most parts of the walk even where footpaths were present. The narrow footpaths do not allow wheelchair users to use them with ease. We recommend that footpaths be widened throughout the route of Jane's Walk.

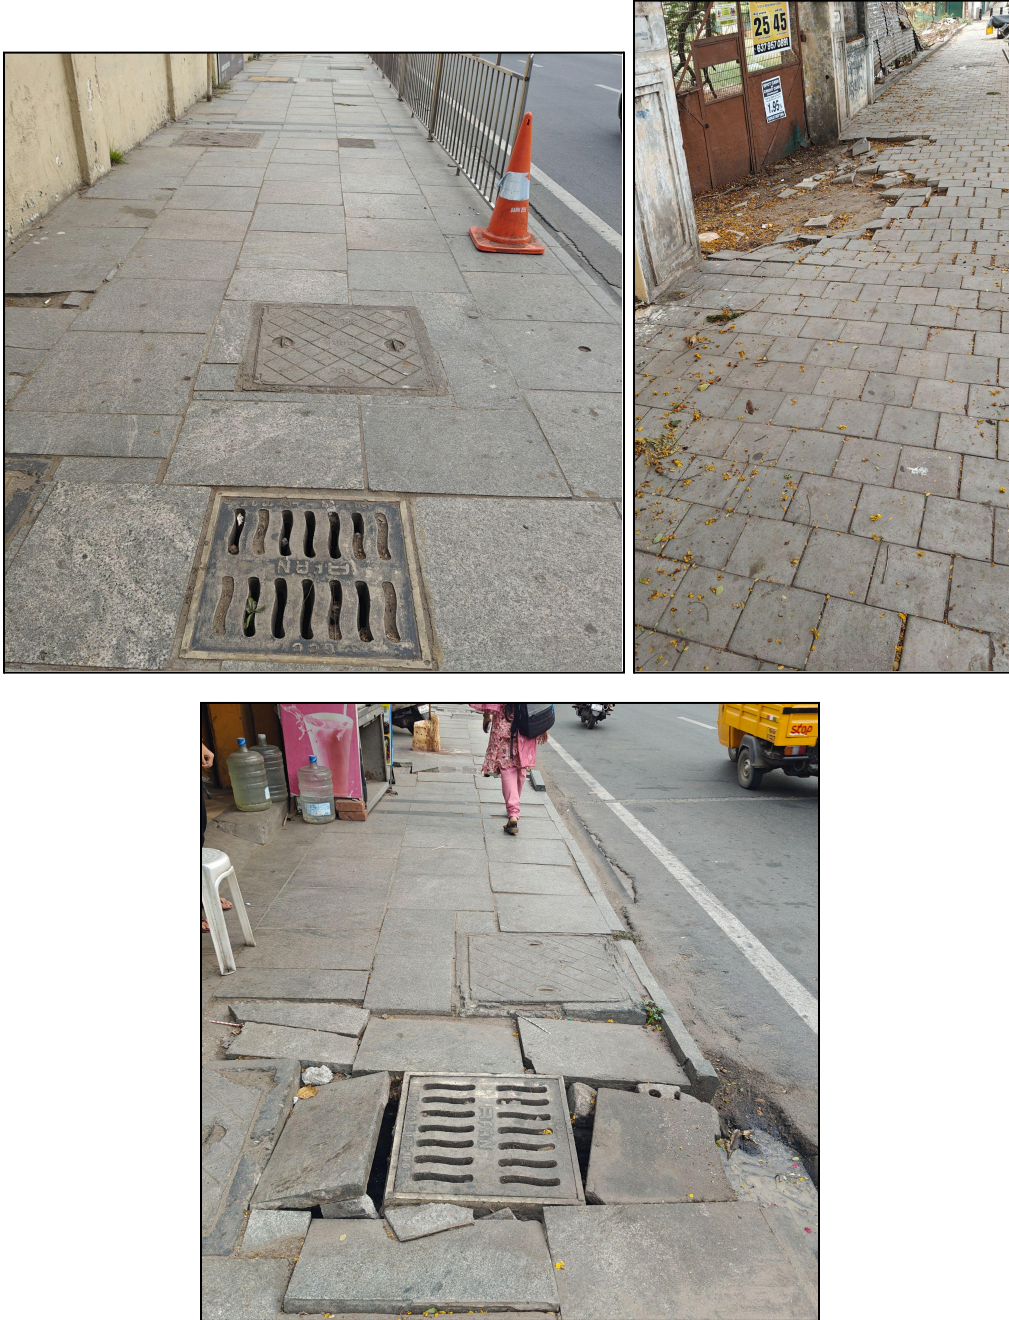
*Uneven footpaths with poor maintenance on the Jane's Walk route* [CAG](#)

As seen above, uneven surfaces are rarely intended by design. Poor road maintenance leads to broken footpaths that create uneven surfaces.

- **Poor Maintenance:** Broken footpaths contributed heavily to lack of continuity of the footpath. Timely and periodic maintenance of footpaths is essential

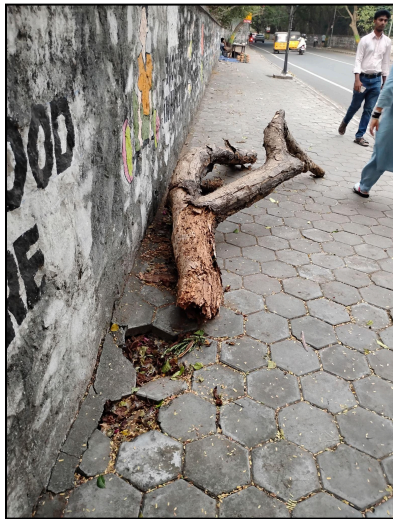
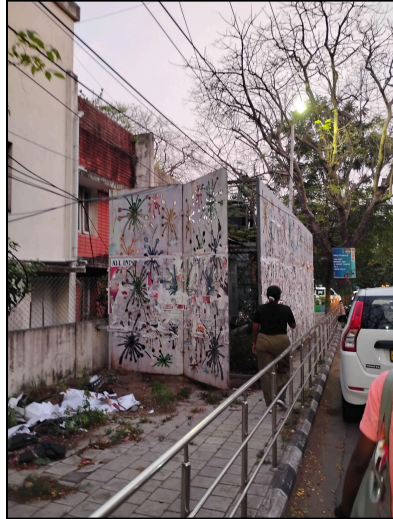
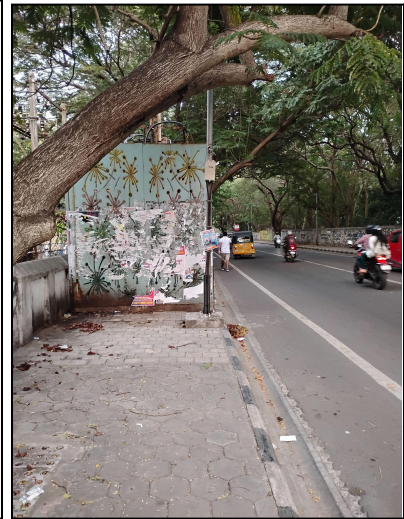
*Various types of obstructions on the Jane's Walk route* | [CAG](#)

As seen above, permanent obstructions such as electricity furniture were abundant on the route. Temporary obstruction such as road cones, broken tree branches and construction material were also present.

- **Obstruction:** Obstructions such as lamp posts, dustbins, electric poles, etc contributed heavily to breaking footpath continuity. The obstructions must be removed and relocated urgently.

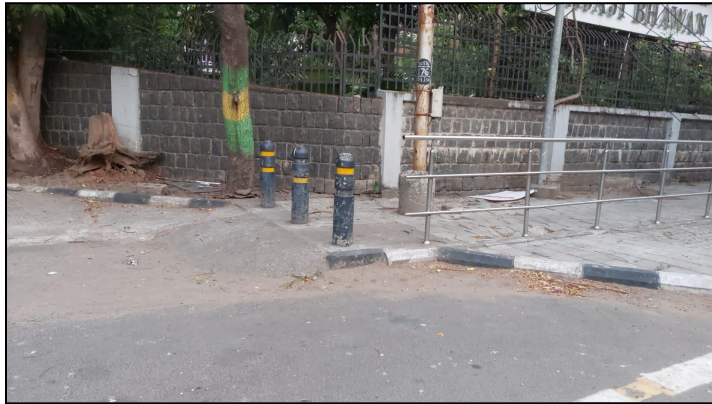
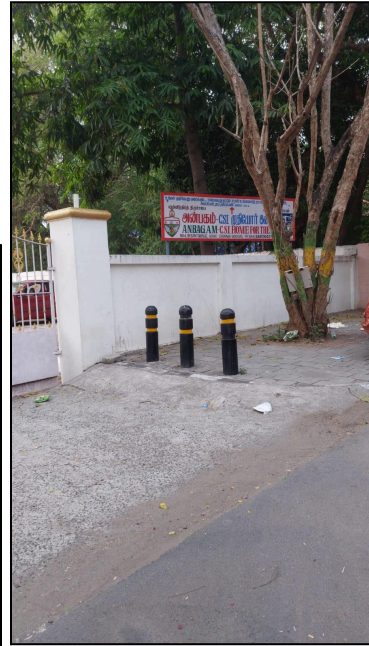
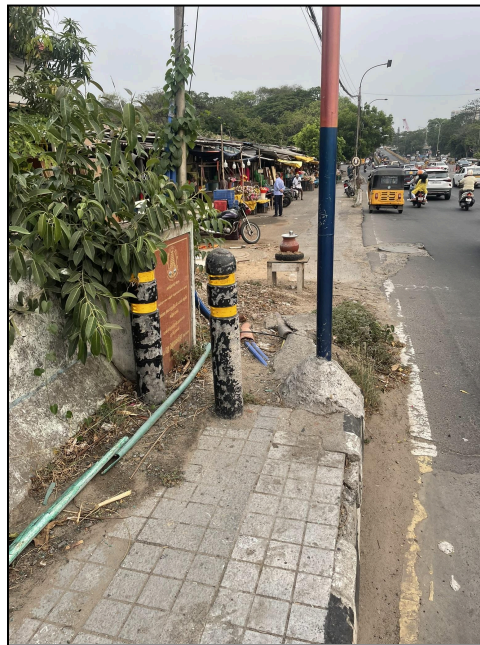
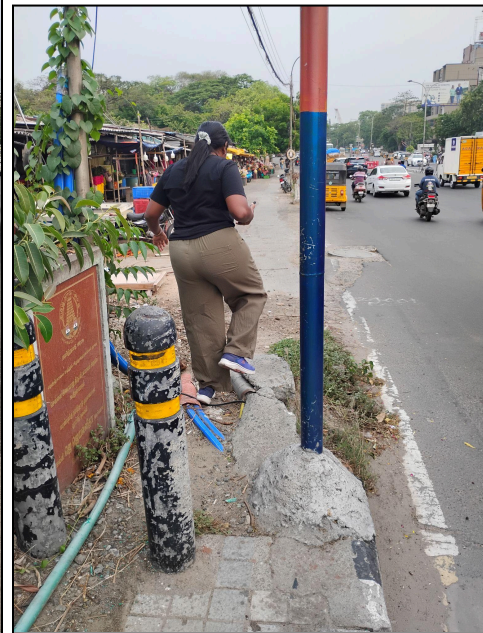
Bollards are placed on footpaths in order to prevent vehicular traffic from entering the footpath. However, in many instances they act as hindrances rather than infrastructure that protects. This is particularly concerning for wheelchair users as the bollards are not placed at a wide enough width to accommodate them. The IRC Guidelines suggest that bollards at suitable locations

should be provided with a clear gap of 1200 mm between two bollards.

*Bollards along the Jane's Walk acting as obstructions rather than lane segregators | [CAG](#)*

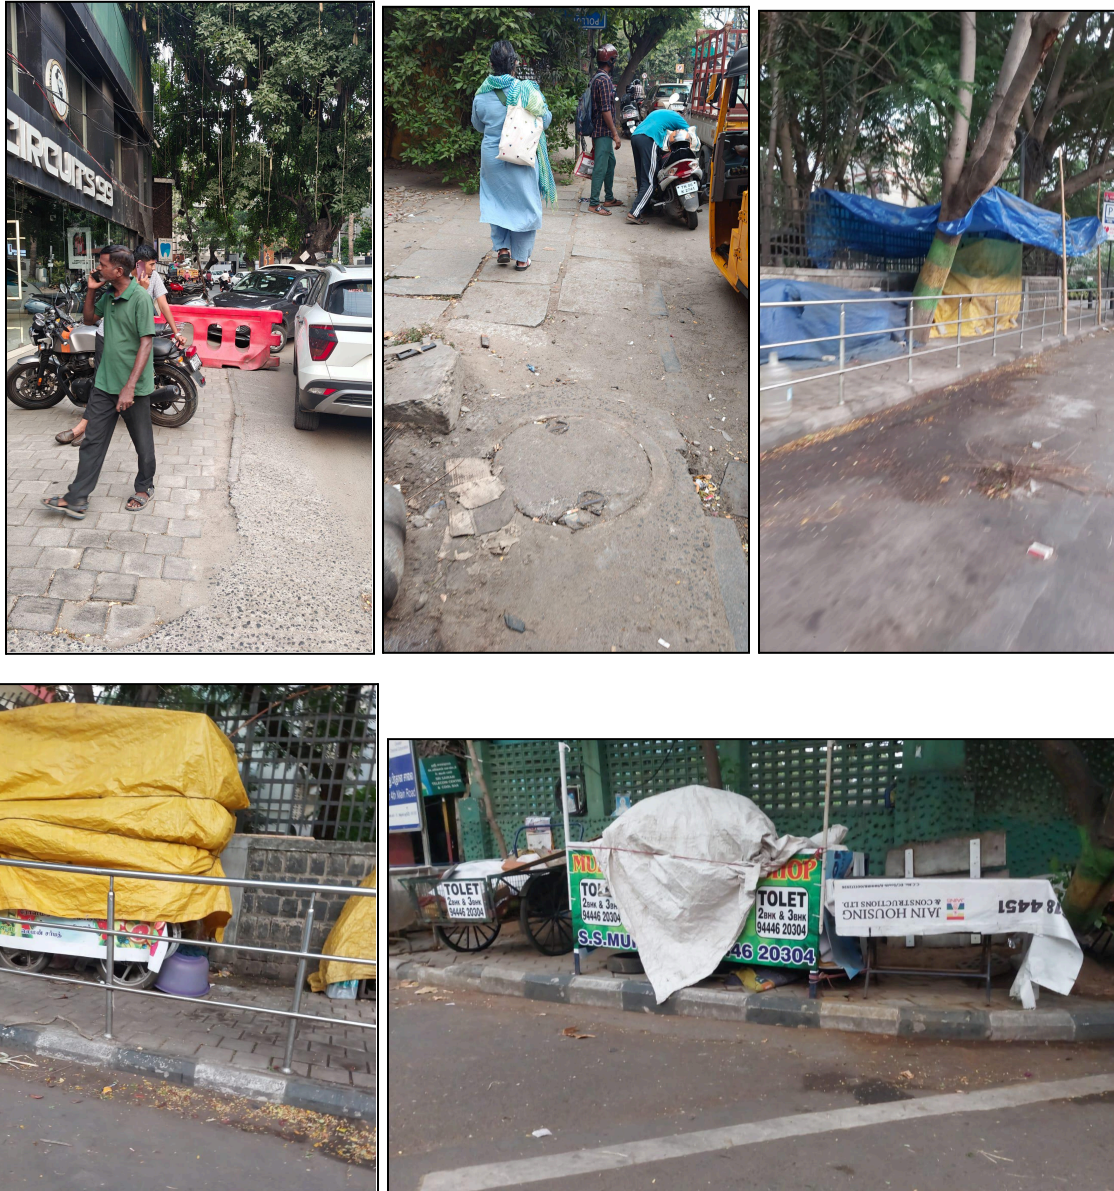
*Parked cars and closed shops on the footpath along the Jane's Walk route | [CAG](#)*

- **Encroachments:** Parked vehicles contributed heavily to footpath continuity along with some vendors. Both need to be accounted for and accommodated into the footpath by design such that they don't affect the pedestrian negatively.

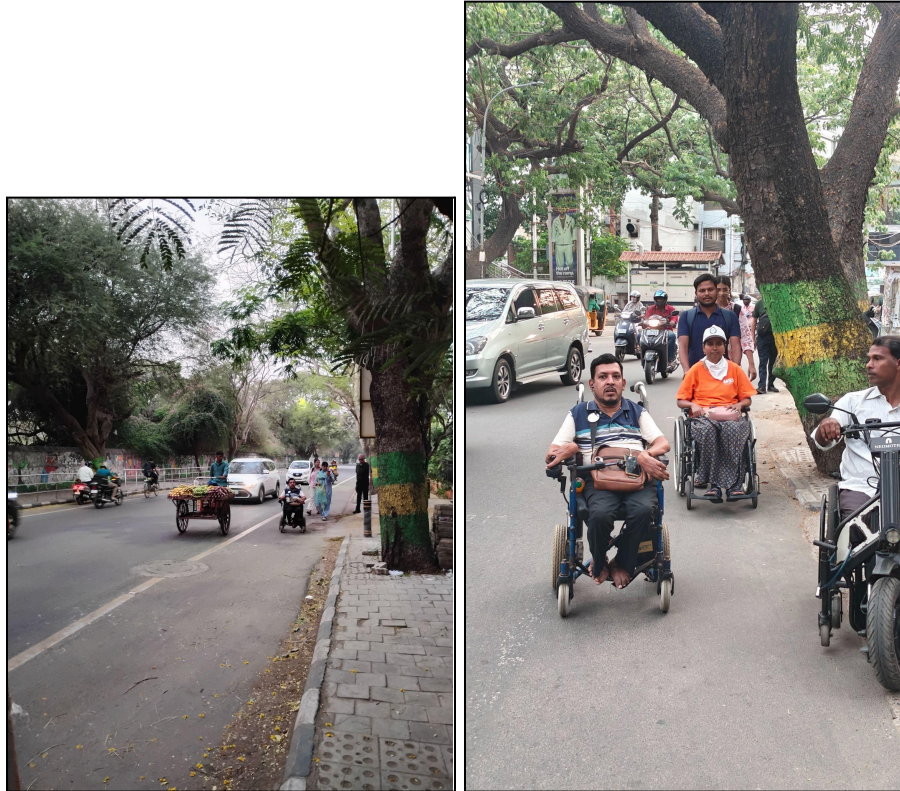
*Participants of the Jane's Walk in close proximity to moving vehicles | [CAG](#)*

As seen above, the potential for vehicular conflict was high on the Jane's Walk route.

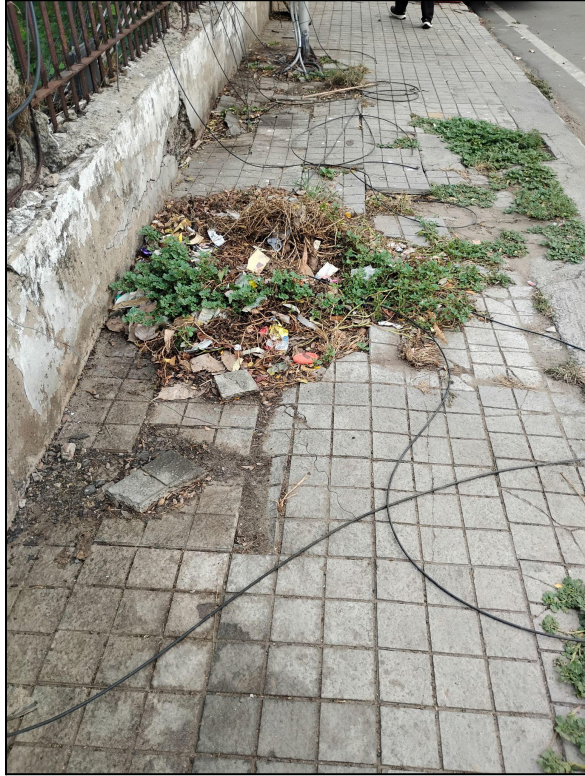
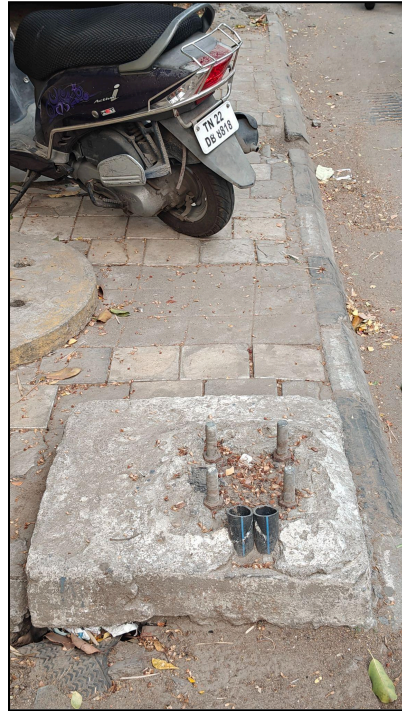
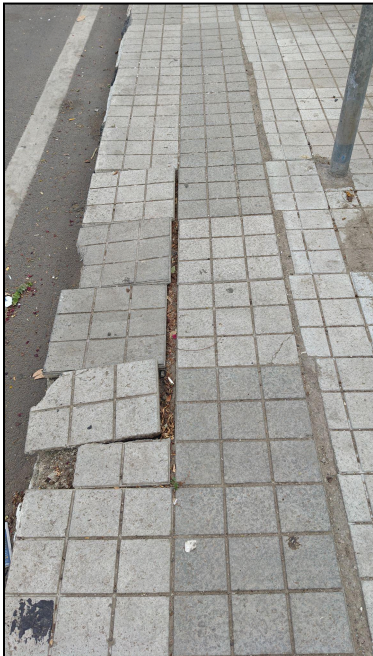
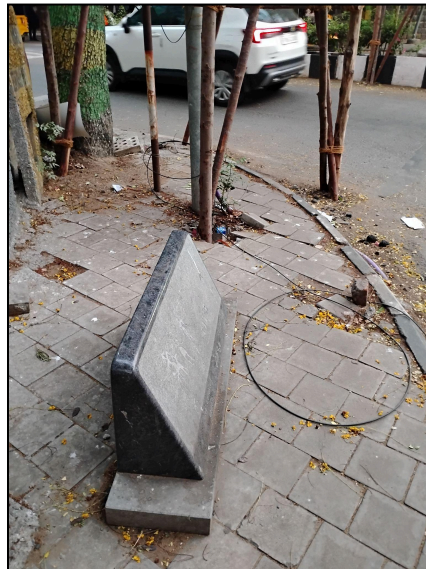
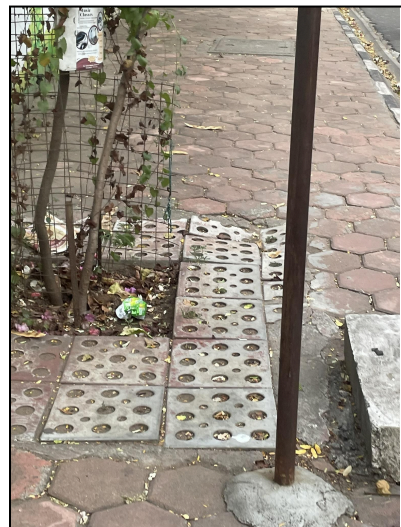
IRC Guidelines underline the importance of the continuity of pedestrian facilities. This is especially important for pedestrians with disabilities and senior citizens. Discontinuous pavements force users onto the roads putting them in danger.

*Discontinuous footpaths along the Jane's Walk route | [CAG](#)*

- **Footpath Continuity:** IRC Guidelines suggest that footpaths should be treated as a transportation system which is connected and continuous, just like roadways and railways. They should not be placed sporadically, but be provided consistently between all major attractions, trip generators and other locations. Footpath continuity was a sustained issue during the course of the Jane's Walk.

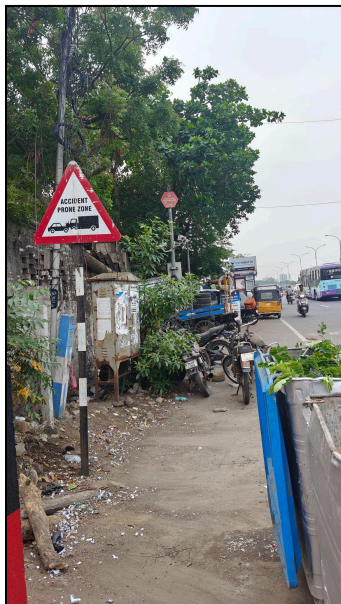
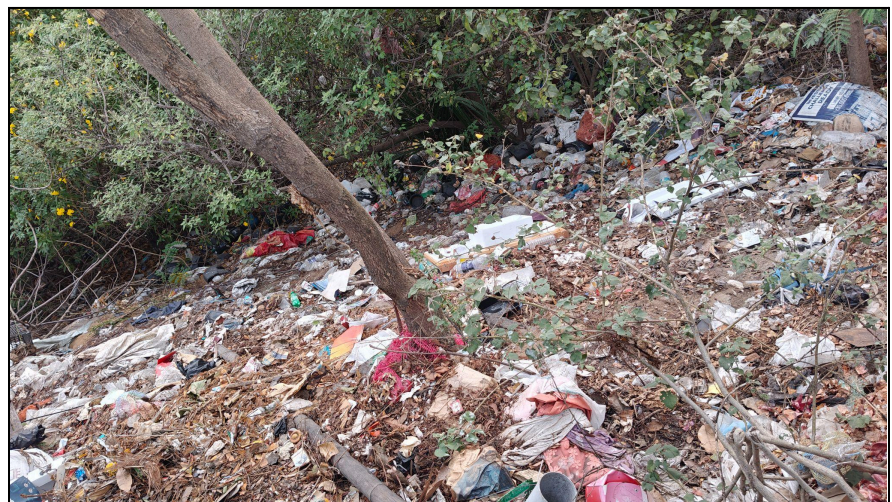
*Waste Management disrupting the picturesque Adyar River near Malar Hospital*

Existing alongside the Adyar River was a local dumpyard near Malar Hospital. While waste disposal was not a prevalent concern during our walk, pockets of dumped waste were found

across the walk, as shown above. This affected the comfort and walking environment of the participants on the Jane's Walk route.

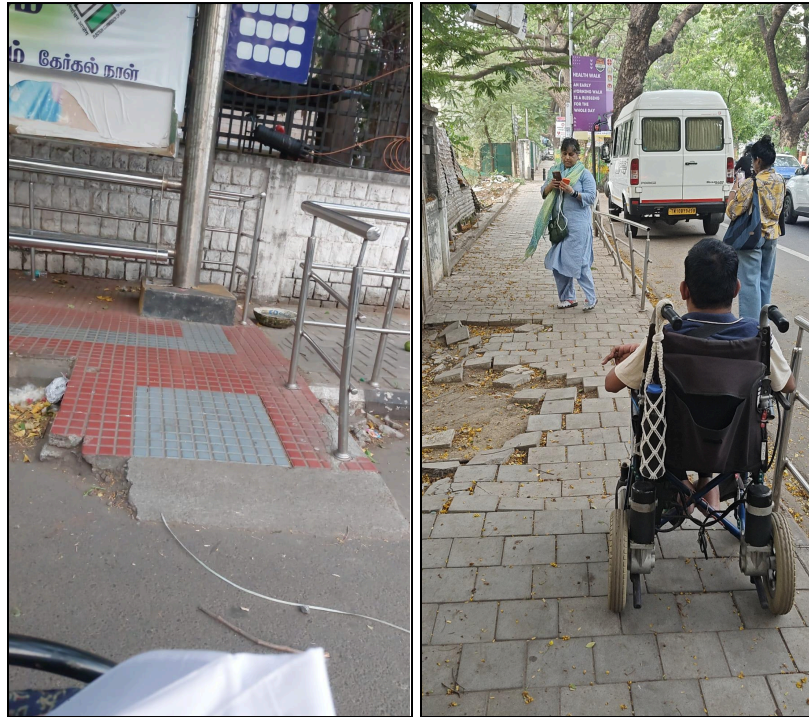
*Broken ramps and footpaths acting as hindrances to accessibility on the Jane's Walk route*

- **Ramps:** Kerb ramps are useful when transitioning between the footpath and carriageway. They are essential for wheelchair users. They were largely absent throughout the walk and need to be established urgently.

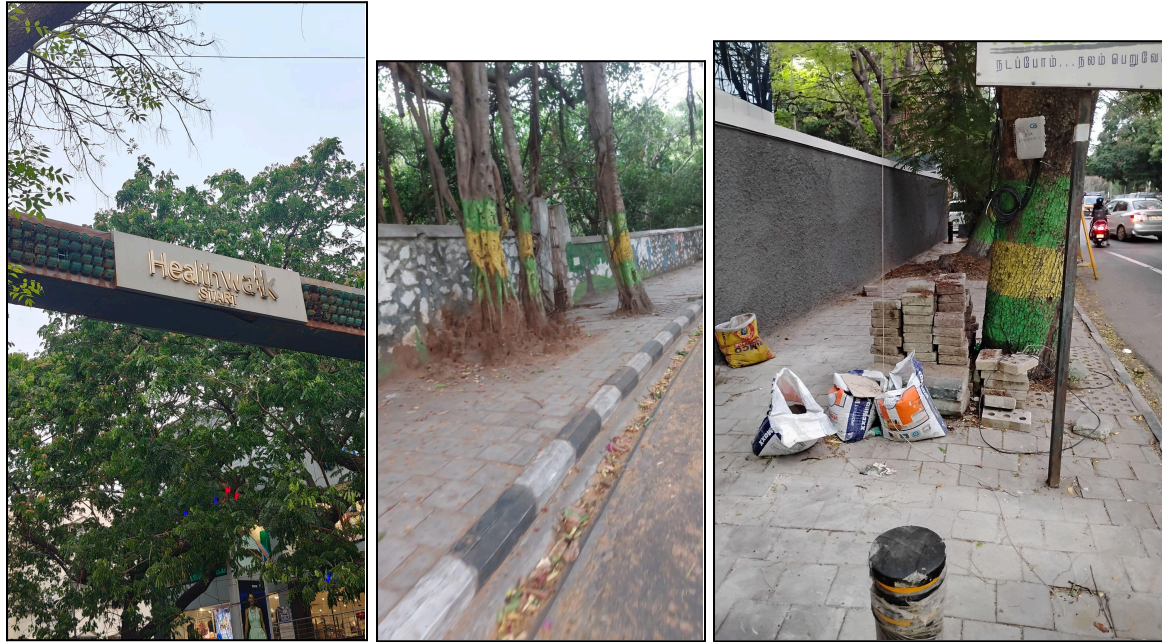
*Snapshots from The Health Walk revealing similar state of pedestrian infrastructure as the rest of the Jane's Walk Route | [CAG](#)*

The findings along the Health Walk Route were largely the same as that along all of Jane's Walk Route. This is shocking given that The Health Walk route was inaugurated as early as 2023.
