SAFE SCHOOL ZONES

Enhancing Sustainable Mobility & Creating Safe School Routes in Chennai

Sowmya Kannan, Researcher, CAG

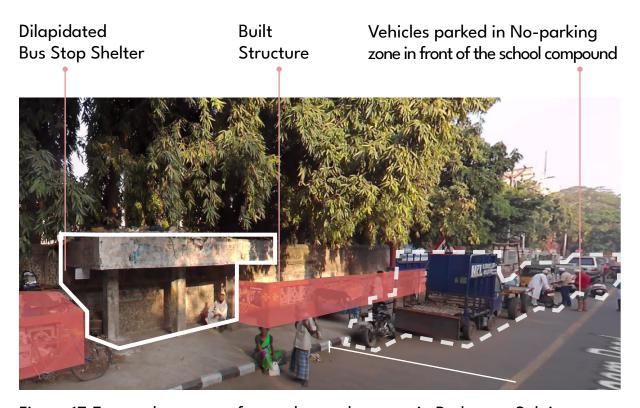
Figure 17. Encroachments on footpath near bus stop in Prakasam Salai

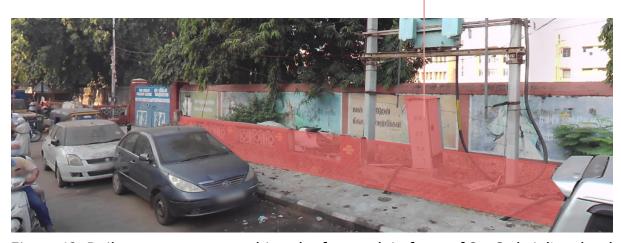
Figure 18. Built structure encroaching the footpath in front of St. Gabriel's school

On St. Xavier's Street, additional challenges arise due to squatter settlements encroaching onto the road and on-street parking reducing the available carriageway width. This obstruction leads to severe congestion, particularly during school drop-off and pick-up hours, as vehicles struggle to enter or exit the narrow passage. The lack of dedicated pedestrian infrastructure and the encroachment of public space not only compromise safety but also hinder the efficient movement of all road users in the school zone.

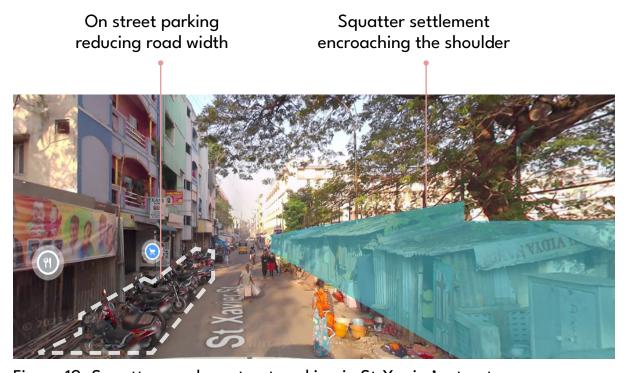
Figure 19. Squatters and on-street parking in St.Xavier's street

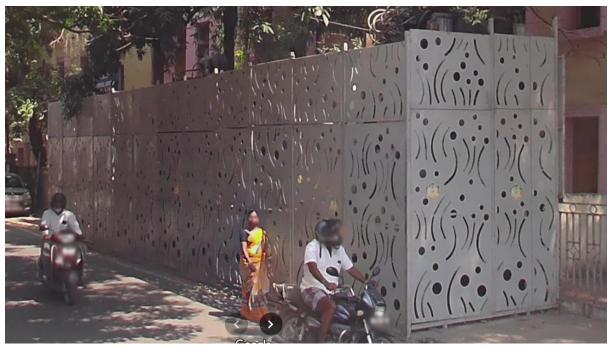
Photo: Transformer near Ramakrishna school | CAG

At the junction near the school gate, a transformer is enclosed by protective panels, encroaching on the already limited pedestrian space. This forces pedestrians, including school children and parents, to walk directly on the carriageway, exposing them to oncoming traffic, which is already congested due to the left-turn restrictions enforced by barricades.

- The existing transformer should be replaced with a more compact RMU (Ring Main Unit), which occupies less space and allows for a wider pedestrian walkway.
- The enclosure panels should be redesigned to minimize the space occupied.

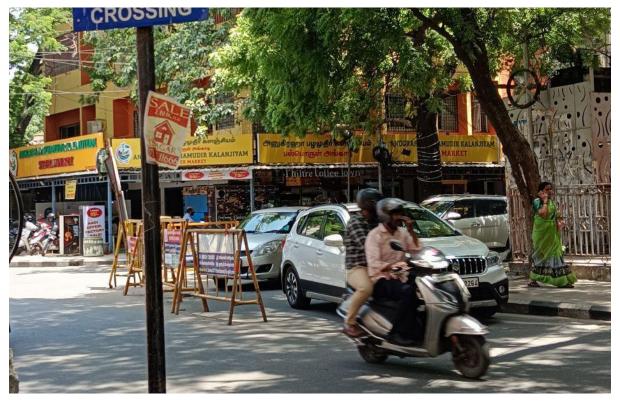
Additionally, barricades have been placed in the middle of the carriageway at the Dhandapani Street junction to enforce left turns. However, this creates operational inefficiencies, as vehicles take immediate U-turns after the barricades, leading to further traffic congestion on Burkit Road.

Photo: Only left imposed using barricades | CAG
