Why Chennai Stinks?

*Citizens' effort to understand
and solve the Sewage problem*

An initiative of **Arappor Iyakkam**

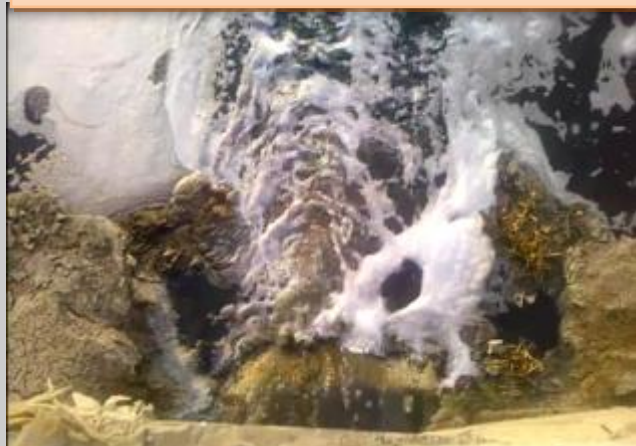
Untreated Sewage Discharged Into Waterbodies in Tiruvottiyur

On further analysis of the area, we found a large quantity of raw sewage is discharged from pumping stations into Buckingham Canal.

According to reply to an RTI (dated 09/03/2017), CMWSSB confirmed that untreated sewage from 6 pumping stations in Thiruvottiyur is discharged into Buckingham canal. Therefore, the raw, untreated sewage collected from entire Area 1 is discharged into the waterbodies without treatment. This is hazardous to the environment, waterbodies, and people living in the area. A minimum of 7.25 MD (million liters of sewage per day) is discharged into Buckingham canal. Following are the details of the pumping stations:

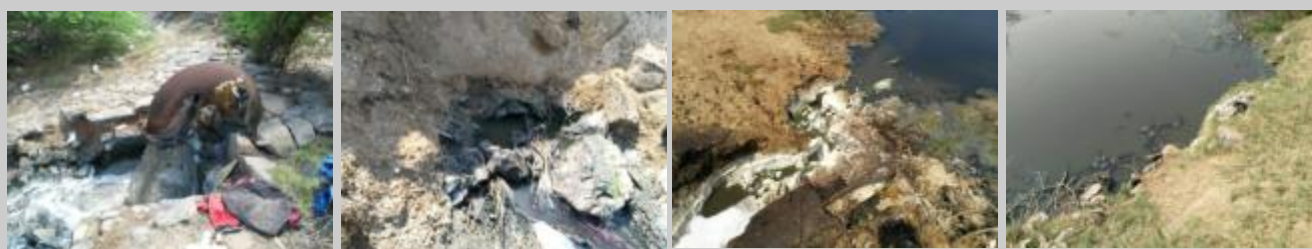
First, the study team audited Kosasthalaiyar river, the waterbody near the pumping station. We found that large quantities of untreated sewage was let into the waterbody. A small pond has been apportioned right next to the river, into which the untreated

Discharge of Untreated Sewage from Manali New Town Pumping Station into Kosasthalaiyar River

this pond flows into the Kosasthalaiyar river.

This sewage discharge is contaminating the waterbody, environment, and causing a health hazard for the people living there.

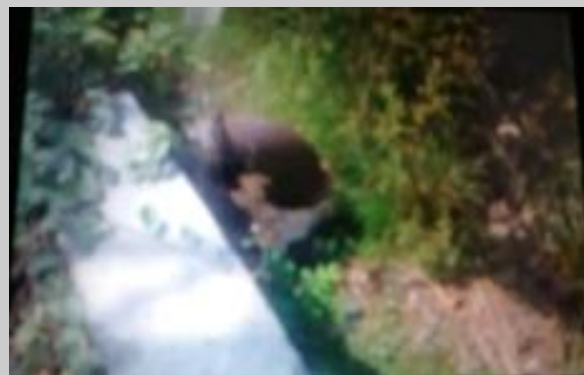
- Only one field operator was present in each of the pumping stations and their education qualification was only middle school. This shows that plant operators are not assigned to the pumping stations.
- Both the operators told that sewage is sent to Bank colony pumping station, and from there it is sent to Royapuram pumping station. From Royapuram pumping station, the untreated sewage is sent to the sea. This shows their lack of knowledge as

Sewage Pipe into Canal near Chandrabrabhu colony PS

untreated sewage should not be discharged into the sea.

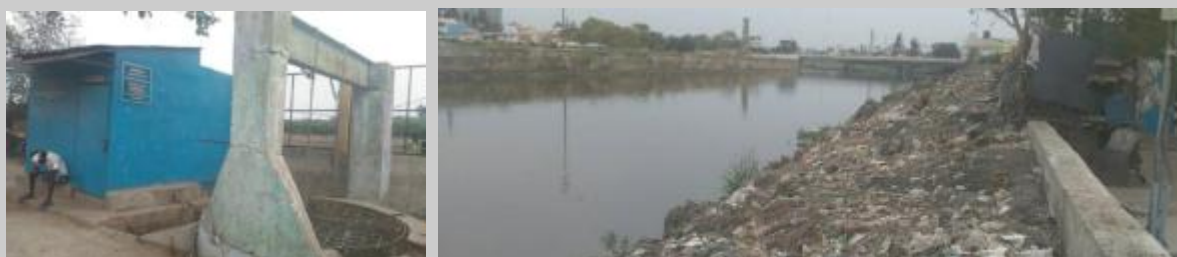
- During our visit to the pumping station in the evening at 5:30 PM, the pumping station was locked, and the operator had left for the day. Right behind the pumping station, we could find a waterbody.
- According to RTI reply from CMWSSB – Kodungaiyur STP, RR Nagar is supposed to send the sewage to the STP but is not sending.
- According to RTI reply from RR Nagar pumping station, the sewage is sent to Kodungaiyur STP.

This discrepancy only shows that the sewage is being discharged in the waterbody.

RR Nagar Pumping Station and the Waterbody Behind the Pumping Station

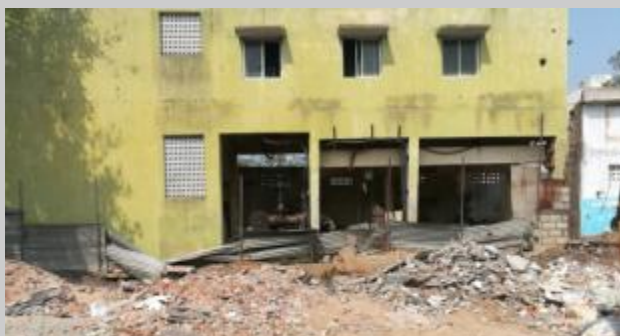
- The walls of the pumping station are broken
- During our visit, a very young teenager was at the pumping station, who was not aware about the functioning of the plant. He was not wearing uniform as well.

Pumping Station on Mint Bus Stand with Broken Walls

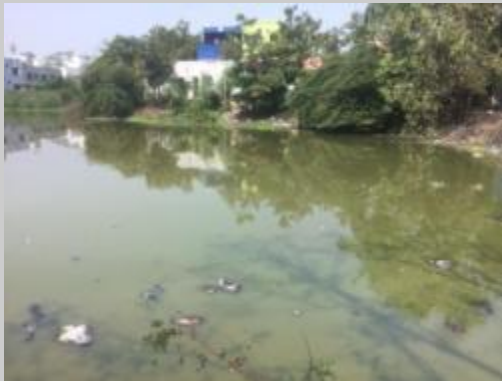
- Untreated sewage from the pumping stations are being let out directly into the Vannankuttai waterbody in GKM Colony located next to the K5 Police Station (Peravallur) Jawahar Nagar. This information was provided by PWD workers who regularly clean this waterbody. Looking at the state of the waterbody, it is

obviously visible that large quantities of untreated sewage is discharged into the waterbody.

Untreated Sewage Discharged into Vannankuttai waterbody

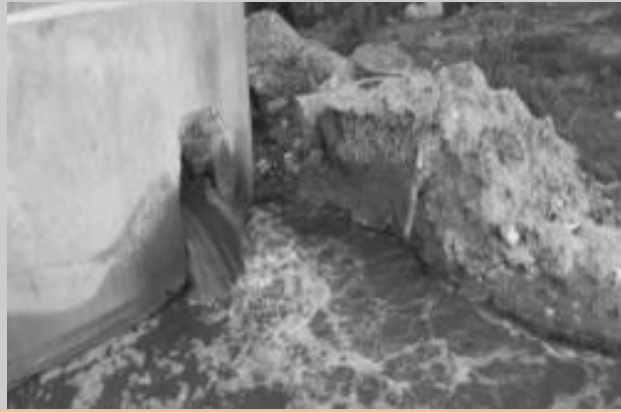
Villivakkam Phase I pumping station: Untreated sewage is discharged into the Villivakkam/Konnur lake. This pumping station discharges at least 3.8 MLD of untreated sewage into the Villivakkam/Konnur lake.

Untreated Sewage Discharged from Villivakkam Phase I Pumping Station Discharging Sewage into Villivakkam Lake

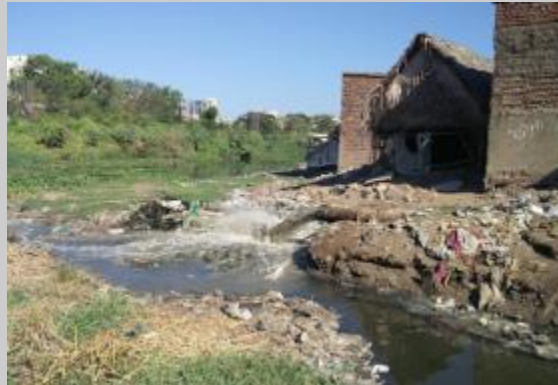
- Greams road Pumping Station discharges untreated sewage into Cooum river.
- This pumping station handles 14 million liters of sewage every day.
- People around are worried that they are developing health issues because of the raw dumping of sewage by the pumping station.

Untreated Sewage Discharged from Greams Road Pumping Station

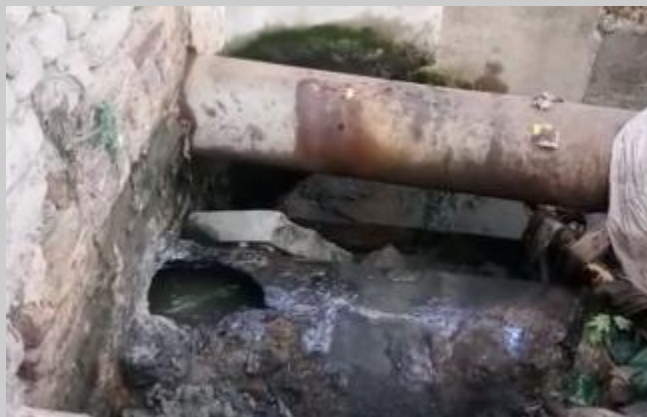
- Sewage pipe from mylapore pumping station is broken, and sewage overflows from the pipe.
- The below image shows flow of sewage due to gravity. Therefore, in case of full flow, the sewage will overflow into the waterbody.

Broken Pipe from Pumping Station to STP

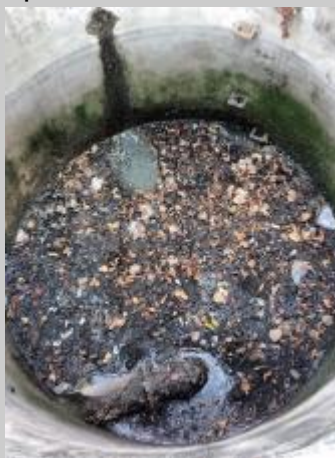
- The well in Thomas road pumping station was filled with solid waste, which will clog the pump and cause operational issues.

Debris in Pumping Station Well

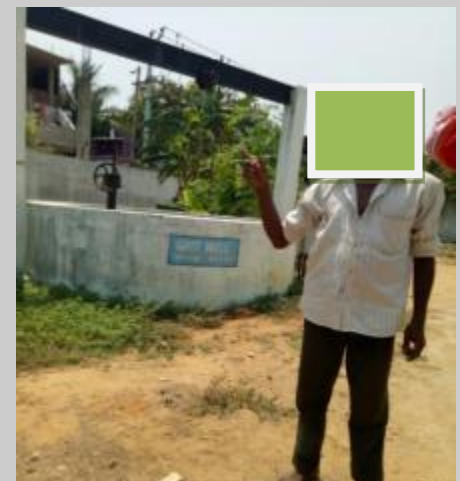
The entire functioning of the pumping station is greatly dependant on the plant/field operators in the pumping station. The maintenance of most of the pumping stations has been outsourced to private agencies. In some pumping stations, the staff were not available. In addition, in one pumping station, we also found an operator socializing with friends (consuming alcohol). In many pumping stations, the staff are not aware of the basic information, such as the place where the untreated sewage is sent, calculation of the amount of flow, and the functioning. In many cases, the staff recruited by the contractors have only high school/middle school education, while the requirement is to have diploma or engineering plant operators. No proper ID cards are issued to the operators. Many-a-times, the operators are not wearing uniforms, as the CMWSSB has provided only one uniform. While the reliability of the operators is questionable, the CMWSSB has given complete control of the pumping station to the operator without proper monitoring.

Operator without ID card and Uniform

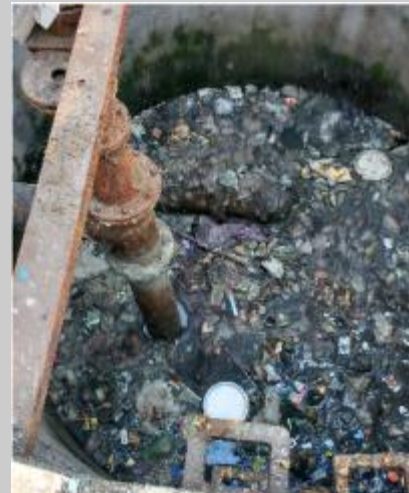
- 5) **Pumping stations with inadequate infrastructure:** Some pumping stations lack very basic facilities. Pumping stations do not have level controllers. The operators switch on/off the motor by manually checking the levels. Many-a-times, there is overflow of sewage from the upstream manhole due to high levels in the pumping stations. Therefore, automated level controller is essential for appropriate functioning of the pumping stations. There are other basic infrastructural facilities, for example, Ayodhya nagar pumping station and Perriyamettu Palayam pumping stations did not have walls around them. In Ayodhya nagar, the wells were not even covered, which could be dangerous. Pumping station near old mint bus stand has broken walls, which was closed with asbestos sheet. Many pumping stations are very old, cover for the well, sand bags, and so on. The pumping station wells in some places are filled with debris, such as plastics. This would choke pumps frequently and cause sewage-build up and overflows. This will also cause pump maintenance and operational issues.

Well in Pumping Station Containing Debris

- **Pumping stations with inadequate infrastructure:** Some pumping stations lack very basic facilities, such as walls. In addition, pumping stations do not have level controllers. The operators switch on/off the motor by manually checking the levels. However, these automatic level controllers can automatically turn on/off the motor based on the sewage level in the wells.

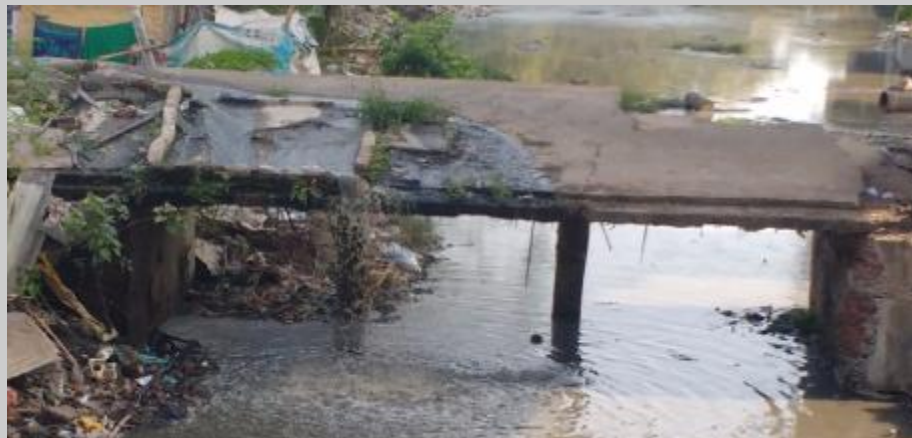
Many of the sewage pipes are damaged and broken, which cause overflow of sewage into the waterbodies.

Sewage Pipe Broken and Causing Overflow

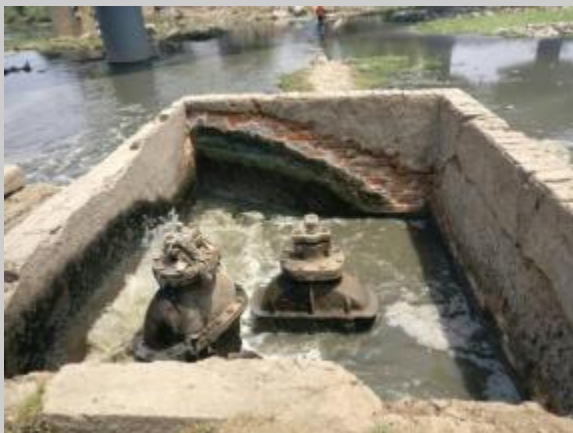
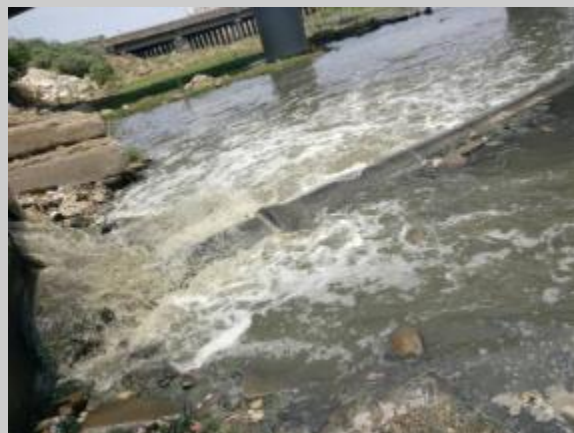
Near Metro Zone apartments in Koyambedu, huge volume of sewage is discharged into the waterbody. The treated sewage from the Koyambedu Treatment Plant is discharged here. However, this treated sewage is brown in colour and has a strong sewage odour, which also indicates that the treatment is insufficient. Treated water needs to be odourless and colourless.

Discharge of Treated Sewage from Koyambedu STP

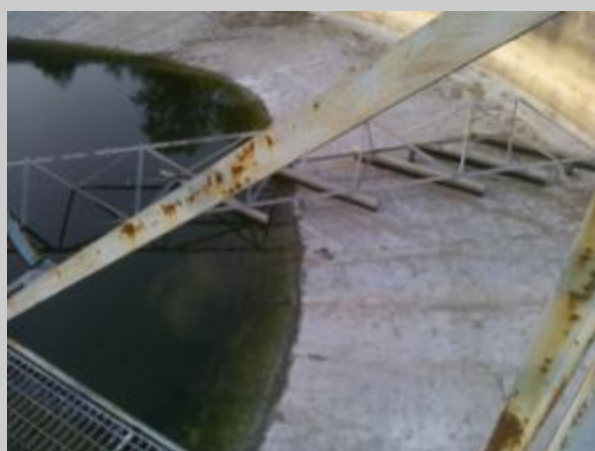
- Zone 1 - 1 Clarifier not working
- Zone 2 - 1 Secondary Clarifier not working
- 7 aerators not working and are broken
- Zone 2 aeration tank was completely filled with foam and foam flying all around the place
- Staircase to some of the tanks was rusted and broken
- No proper flow meters and sludge handling mechanisms

Clarifier Not Functioning

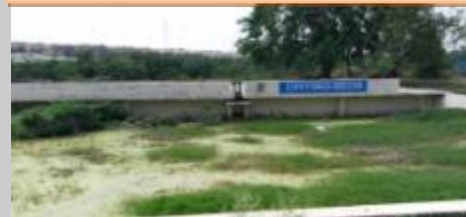
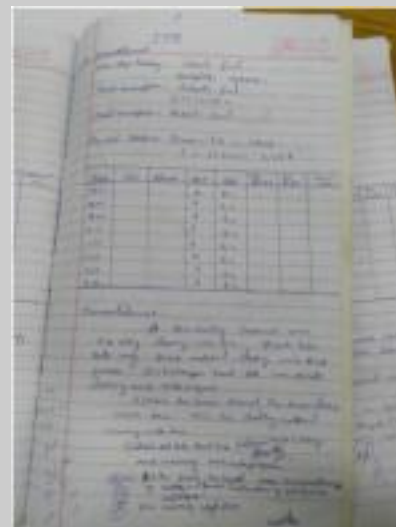
- No proper water circulation in the primary clarifier
- Secondary clarifier is not working
- Foaming in Aeration tank and very less earthy smell
- Only 3 out of the 10 drying beds were being used. The reason given was low sludge generation, which again shows that the treatment is not sufficient.
- Hand written log book, which provides scope for manipulation of data, inadequate data recording, lack of clarity, and control by one person
- The actual and operating capacity of the Alandur STP is 12 MLD while it receives 12.50 MLD from Nilamangai nagar pumping station. Therefore, it receives more sewage that the actual capacity.

Improperly Maintained Drying Bed in Alandur STP

Hand Written Records in Alandur STP

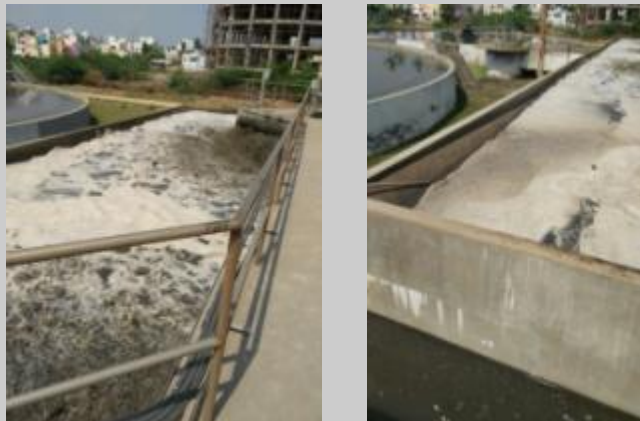
The below images show foaming in aeration tank.

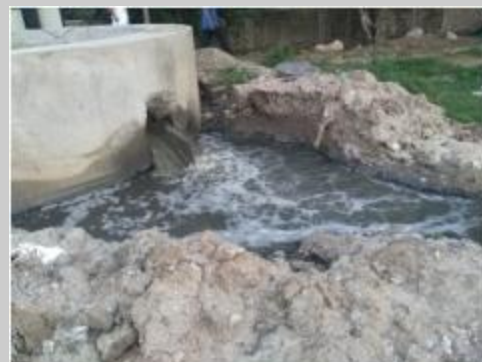
The Villivakkam Sewage Treatment Plant is nothing but the Villivakkam/Konnur lake. The raw sewage collected from around Villivakkam is discharged into the Villivakkam/Konnur lake directly without any treatment. Each day, close to 5 million liters of sewage is discharged into the lake. This has polluted the lake and caused complete degradation of the waterbody.

Untreated Sewage Discharged into Villivakkam Kannur Lake

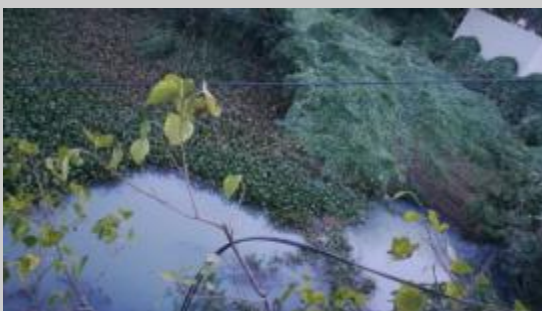
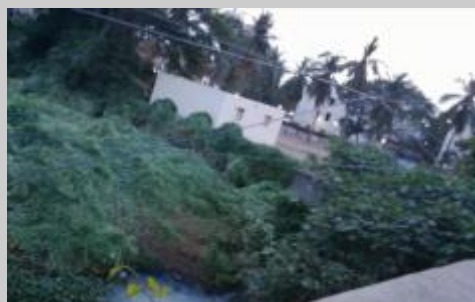
Across Chennai, illegal residential and commercial sewage lines discharge waste into waterbodies. This is not restricted to areas where underground sewage connections are not available. Illegal connections into waterbodies is a problem in nearly all areas of Chennai.

The above images show illegal sewage discharge into a waterbody near the Hindustan Bible Institute & College in Medavakkam Tank Road, Kilpauk.

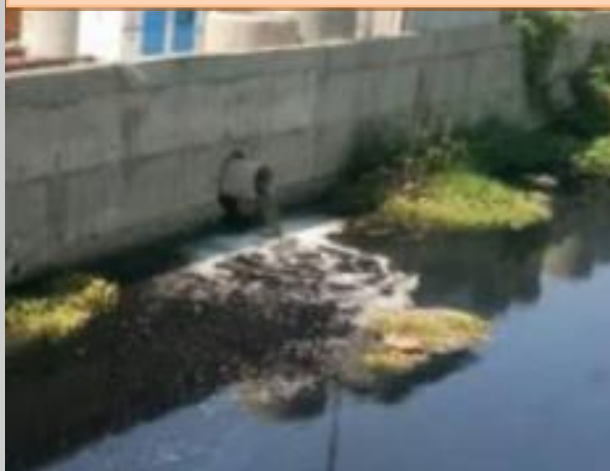
Untreated Sewage Discharged into Waterbody in Thiruvottiyur

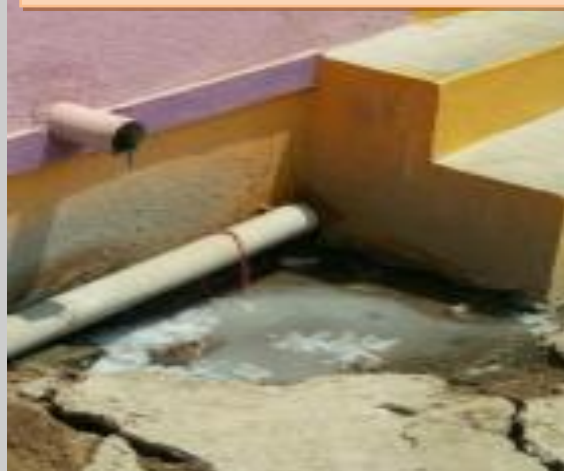
Untreated Sewage Discharged in Madhavaram

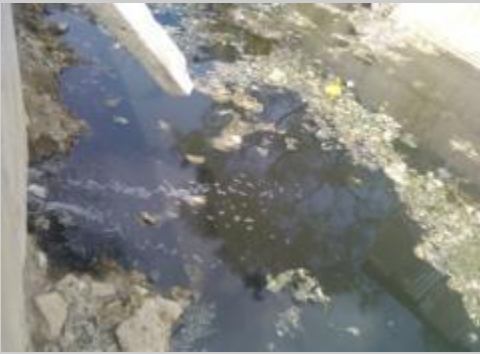
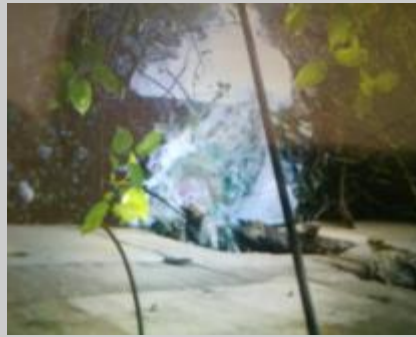
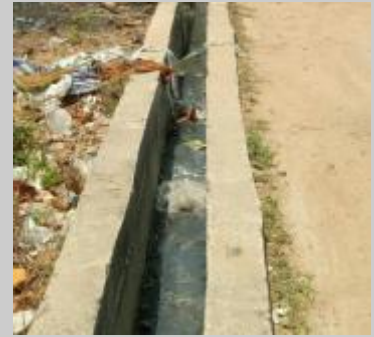
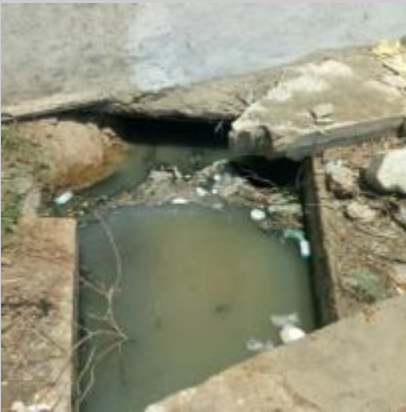
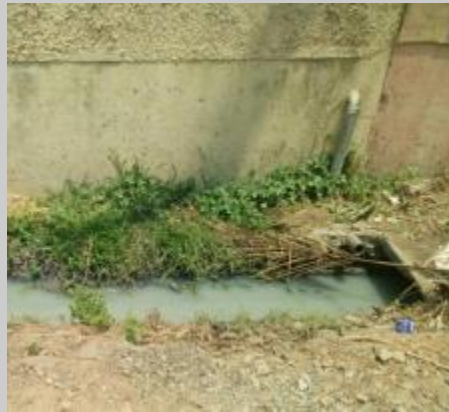
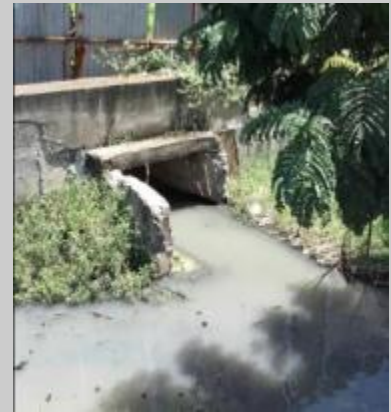
Raw Sewage in Storm Water Drains Across Chennai

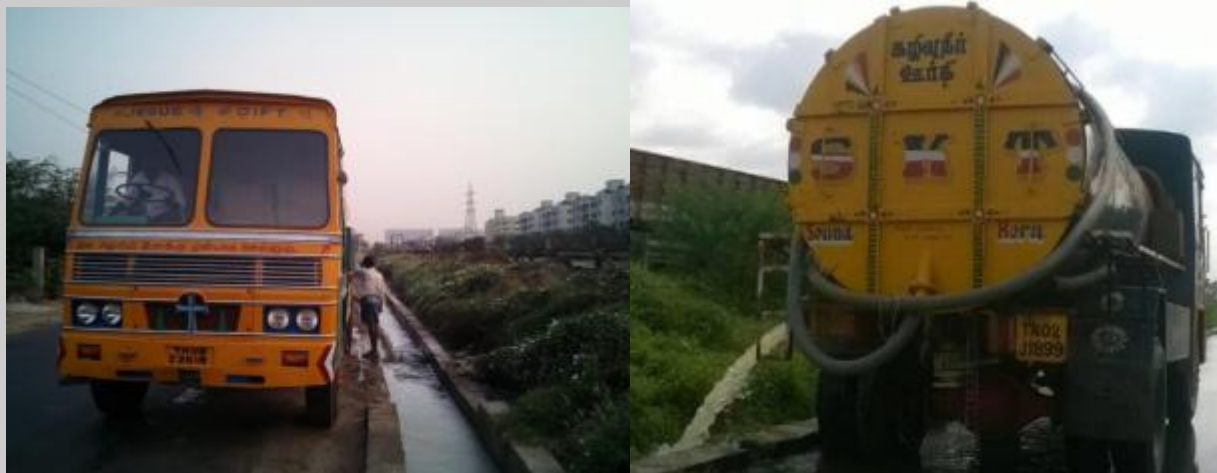
Lorries Discharging Sewage Into Water Bodies / SWDs

Many areas still do not have underground sewerage connections. In these areas, septic tanks are maintained and lorries collect sewage from these places. The lorries are meant to discharge the sewage at STPs by paying Rs 100. However, many of these private, registered lorries discharge the sewage into waterbodies, storm water drains, and canals. However, metro water or PWD does not take any preventive measures. If complaints are filed, the metro water says that monitoring private lorries is not within their scope. While for specific case in Kil Ayanambakkam (photo given below) the corporation suggested that this is outside their scope, and this belongs to Thiruverkadu municipality. There is no departmental accountability to monitor, prevent, and punish discharge of raw sewage into water bodies.
