REPORT ON COASTAL ENCROACHMENTS AND BEACH USE CONVERSION IN CHENNAI

At the request of Save Chennai Beaches Campaign, a fact-finding tour of the coast of Chennai between Light House and Thiruvanmiyur was conducted on September 29, 2012, to document instances of Coastal and riverine wetland Encroachments and land use conversion. Leading the fact finding were T.K. Ramkumar, a lawyer and environmentalist familiar both with environmental laws and the environment, and Kartik Shanker, a marine turtle specialist and faculty at the Indian Institute of Science, Bangalore.

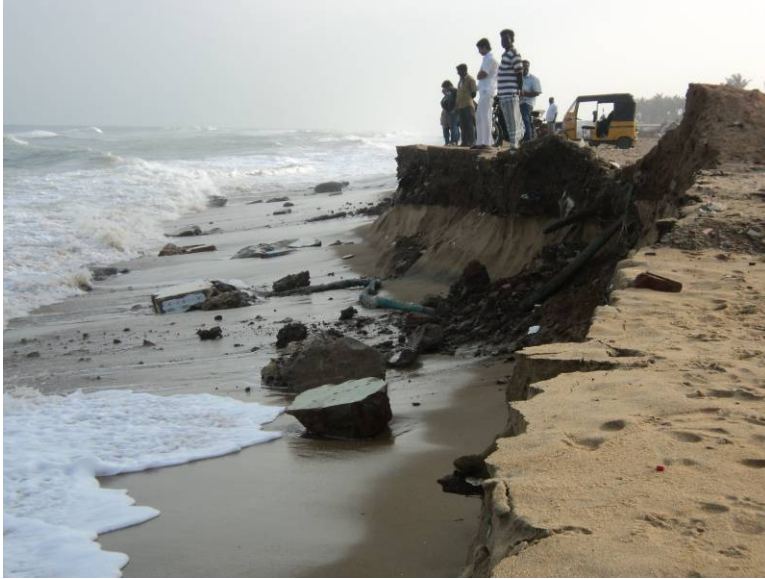
At the time of the site visit in September 2011, this portion was filled with construction debris to a height of about 2 meters, right upto the waterline. The debris had been compacted and made into a vehicle parking space. Enquires with the local fishermen revealed that each year, this beach was filled with debris to enable vehicles to drive up to the sea front and immerse idols post the Vinayaka Chaturthi Celebrations. Since our visit was conducted immediately after the Chaturthi celebrations, we witnessed piles of wood, plastic and other synthetic decorative waste washed up on the now constricted intertidal zone. Over the years, the filled-up site is being used for parking buses and other vehicles. The filled up portion of the beach as well as the surrounding stretches of sandy beach were littered with plastics. Dumping and compacting of debris right up to the waterfront has interfered with the South to North littoral drift and caused considerable erosion of the coastline just north of the land filled areas. **[See Photo 1]**

1. Beach erosion at Pattinapakkam caused due to dumping of debris close to the waterline (Sept 2012).

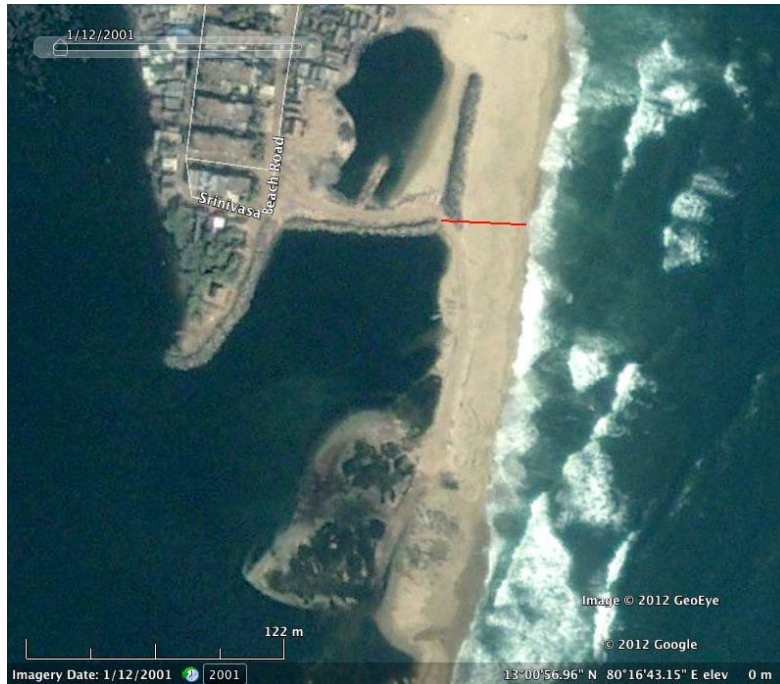
2. Google Earth image as on Jan 12, 2001

The second site visited was the stretch of beach south-east of Srinivasapuram abutting the Adyar Estuary. From a comparative study of the Google Earth historical imagery from 2001 to 2011, it can be seen that the coast at this point is very dynamic. The red-coloured line on the 2001 image indicates the width of the sandy beach. This had virtually disappeared in 2010, perhaps due to sea erosion. The 2011 image reveals a road running north to south. [See Photos 2, 3, 4] At the time of the visit, there was visible evidence of the road having been removed recently, with pieces of debris still mixed with the beach sand. The road had been removed, albeit improperly and unscientifically, pursuant to the interim order dated 7 August, 2012, of the National Green Tribunal in a case (Application No. 7/2012) filed by K. Saravanan. According to the local residents, construction debris was dumped by PWD contractors from the Srinivasapuram Beach Road to the water front to lay a road running North to South upto the mouth of the Adyar River to allow heavy vehicles to transport sand mined from the river and beach. The mining project was shelved after popular protests.

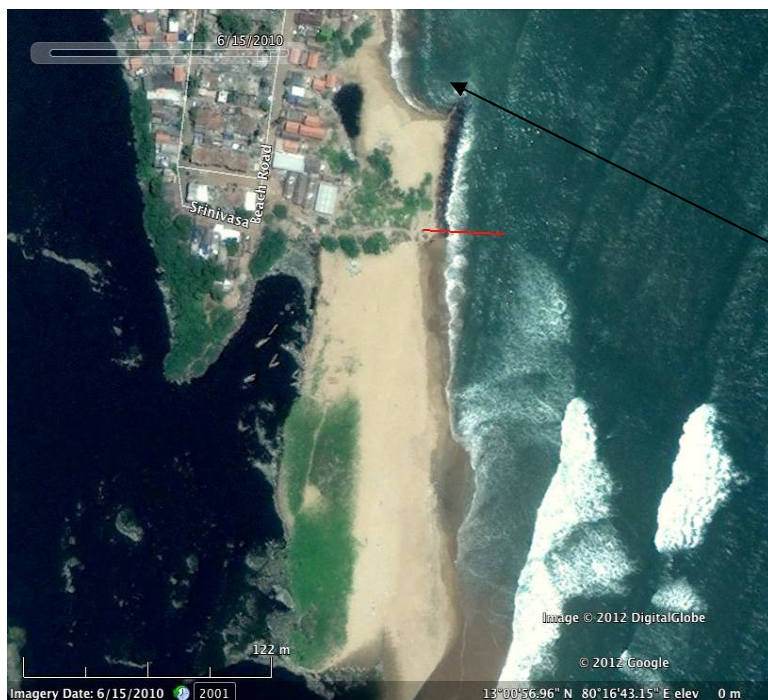
In addition, a seawall that was constructed several years ago to arrest erosion has characteristically resulted in erosion north of the seawall as can be seen from the 2010 google earth image below. [See Photo 3]

3. As of 2010 the pond has disappeared and significant sea erosion is noticeable in the northern half of the photograph.

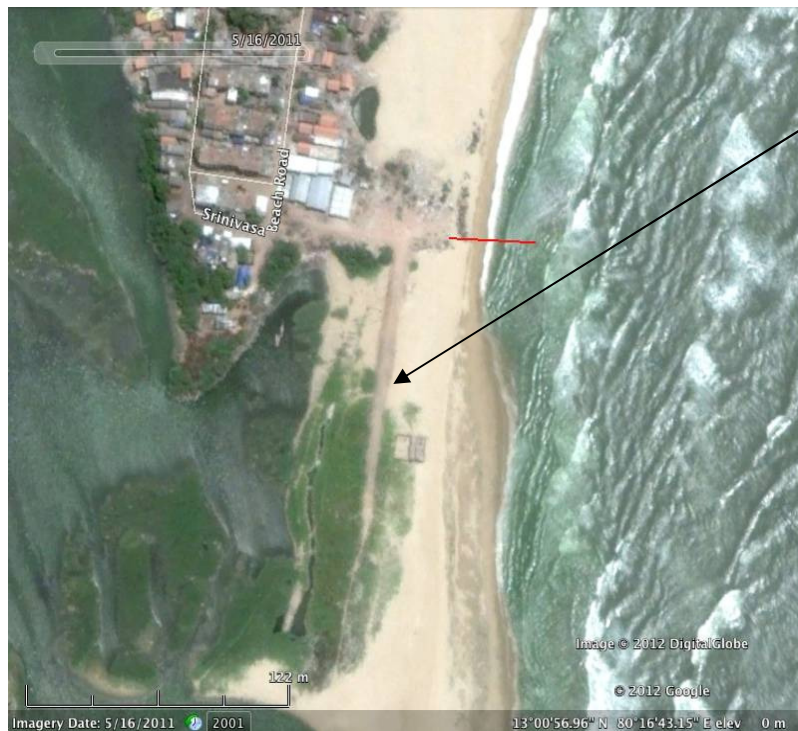
4. 2011: A road has been laid running North to South, towards the river mouth.
